Schempp-Hirth Discus b and Discus CS gliders - Flight Controls

16 March 2015

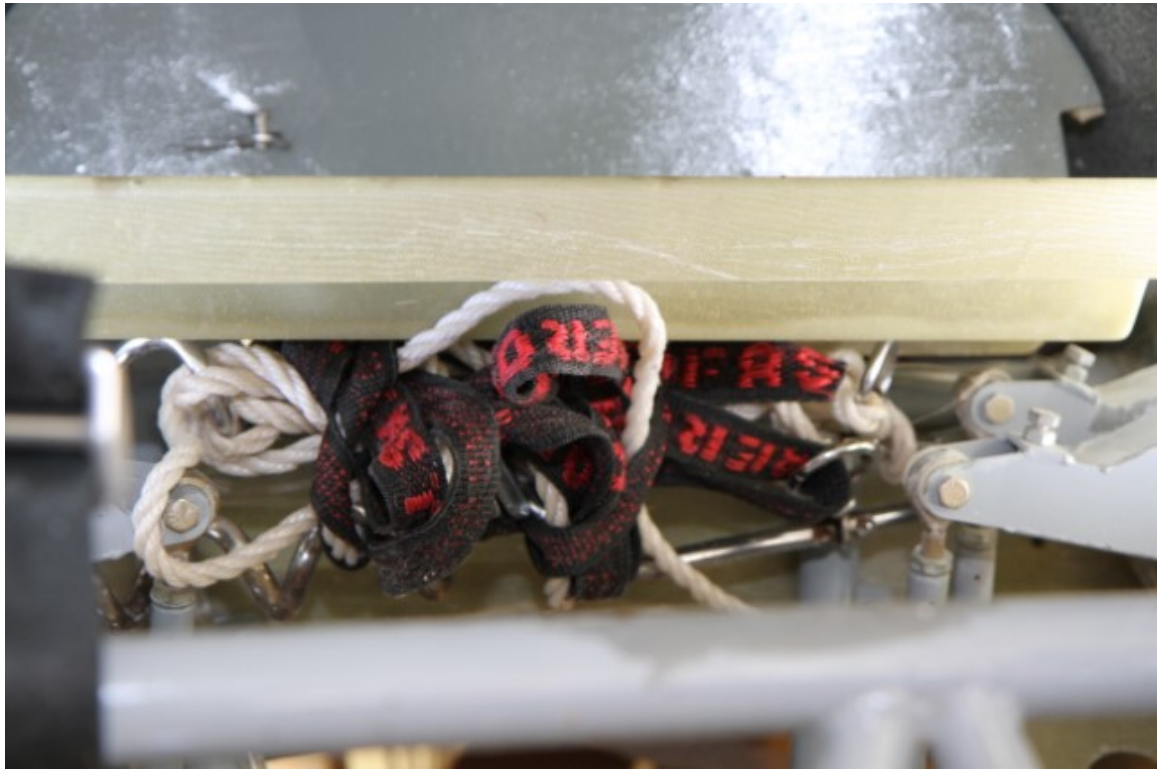
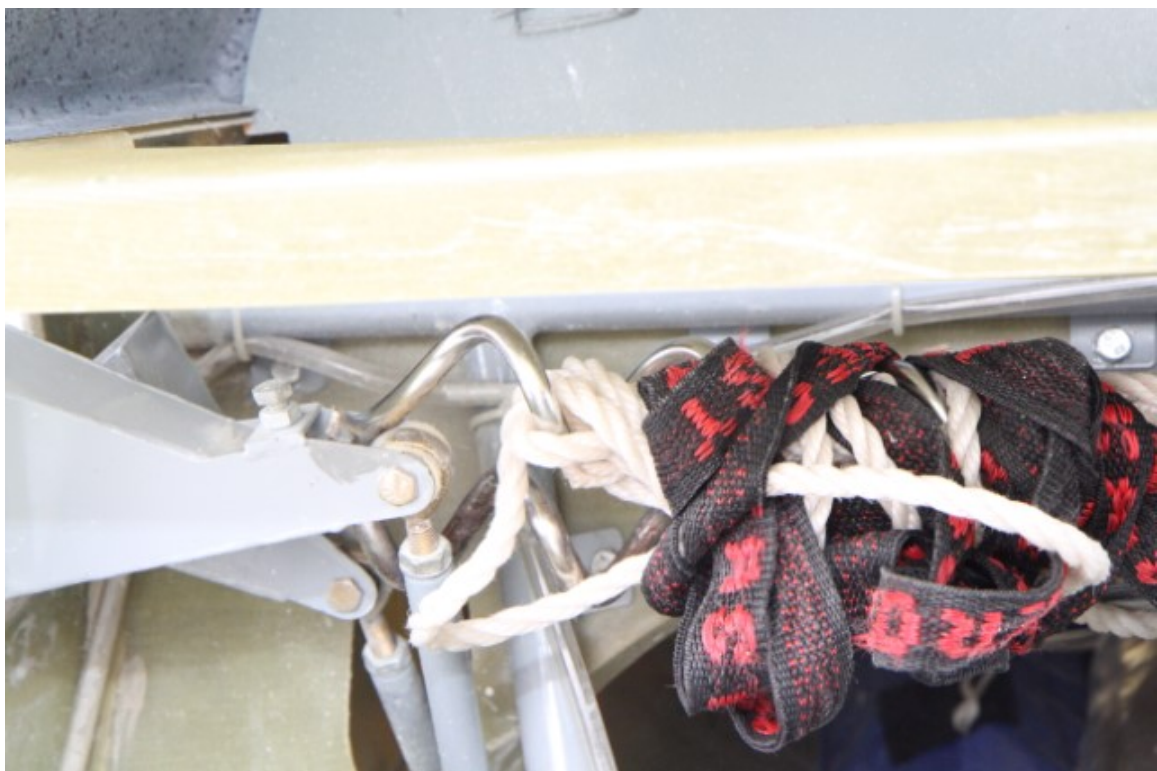
- Two picketing ropes and steel pegs were found jammed in the flight control mechanism located in the centre fuselage.
- The unsecured picketing equipment had fallen through the gap between the stowage tray and the aft bulkhead.
- The picketing equipment restricted full aileron movement to starboard.
- The control system restrictions made the glider uncontrollable and the aircraft was destroyed.

Picketing equipment jammed in the centre fuselage flight control system.

Before every aircraft rigging inspect the stowage tray for correct position, and after every aircraft rigging ensure that the stowage tray is located all the way to the aft bulkhead and locked by the wing spars. There should be no gap through which any stowed equipment can enter the aircraft empennage and the flight control system.

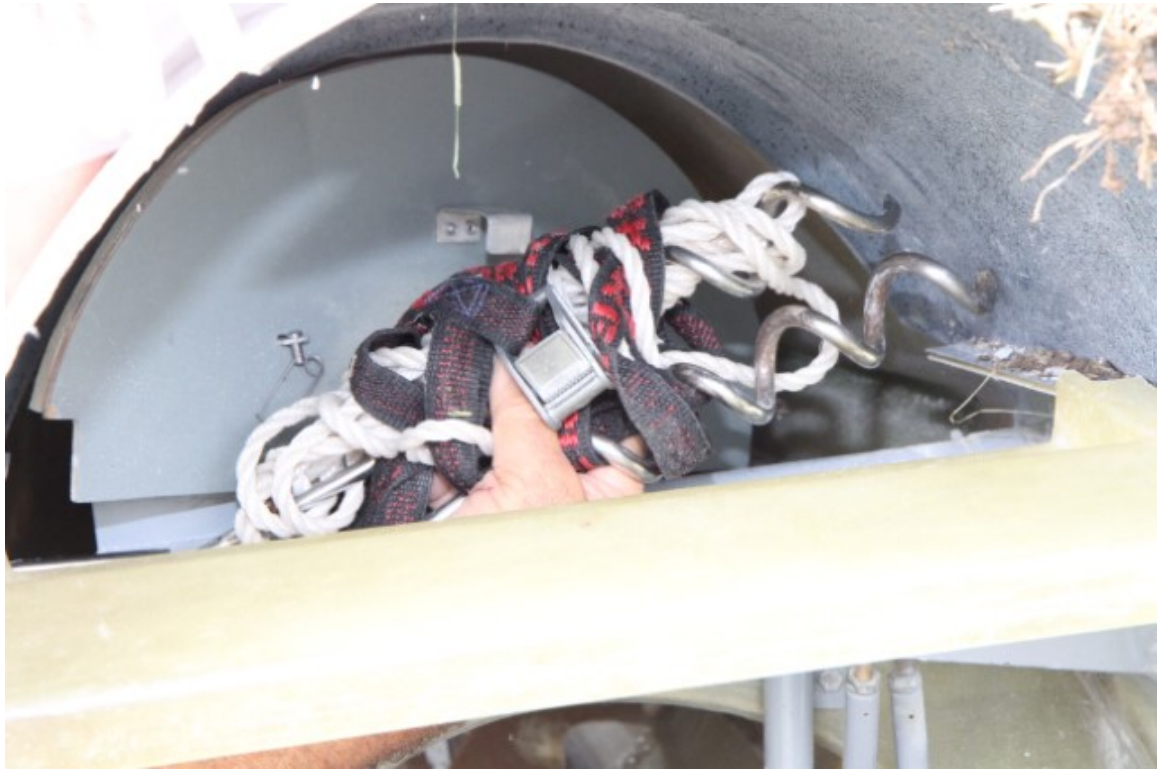
Demonstration of the gap between the stowage tray and the aft bulkhead which is difficult to detect when looking aft.

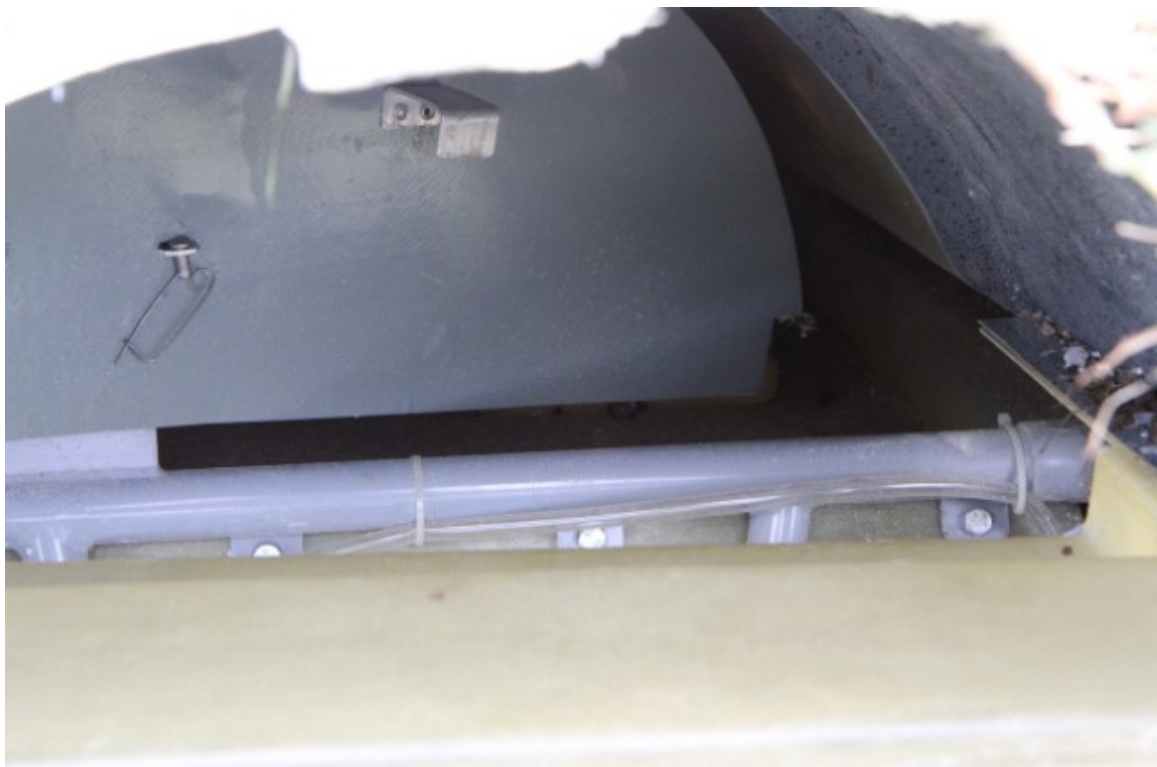
Stowage tray bulkhead to main fuselage detail.

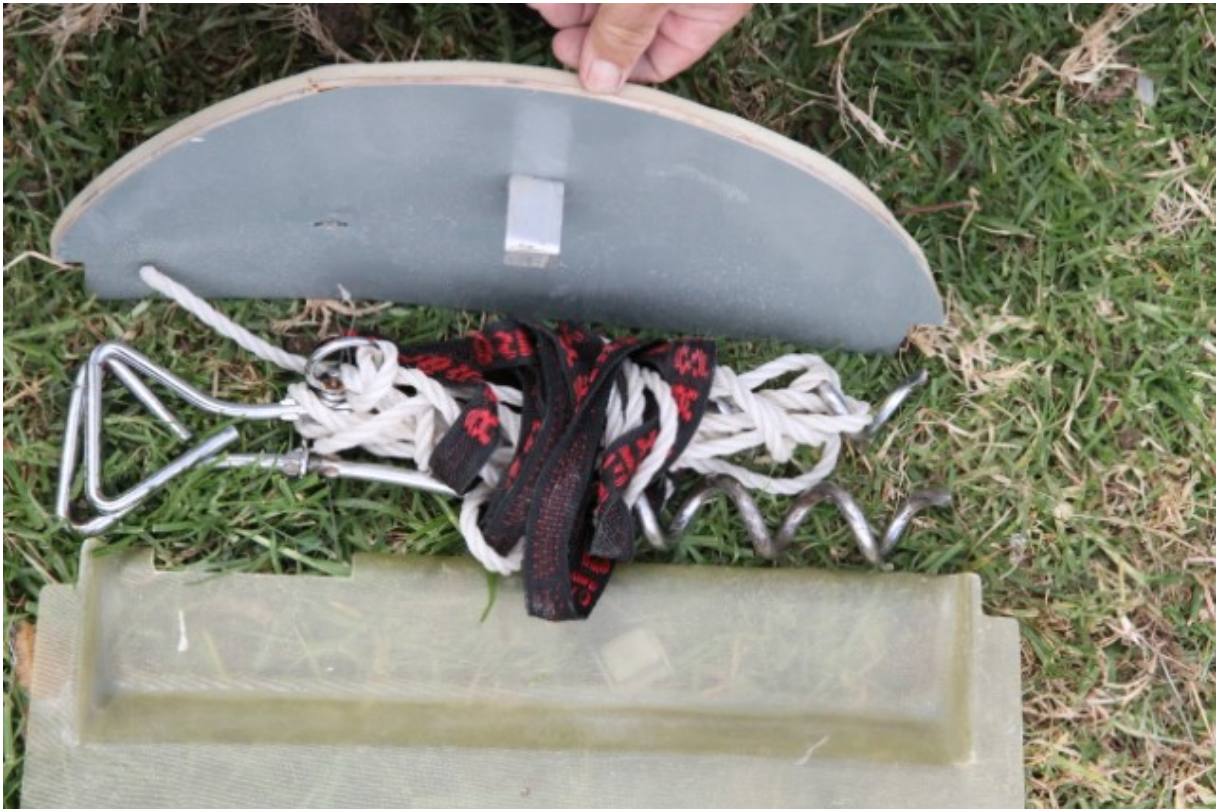
Demonstration of stowage tray to aft bulkhead installation due to incorrect rigging and the resultant gap which results in an undetected gap through which stowed equipment can enter the flight control system.

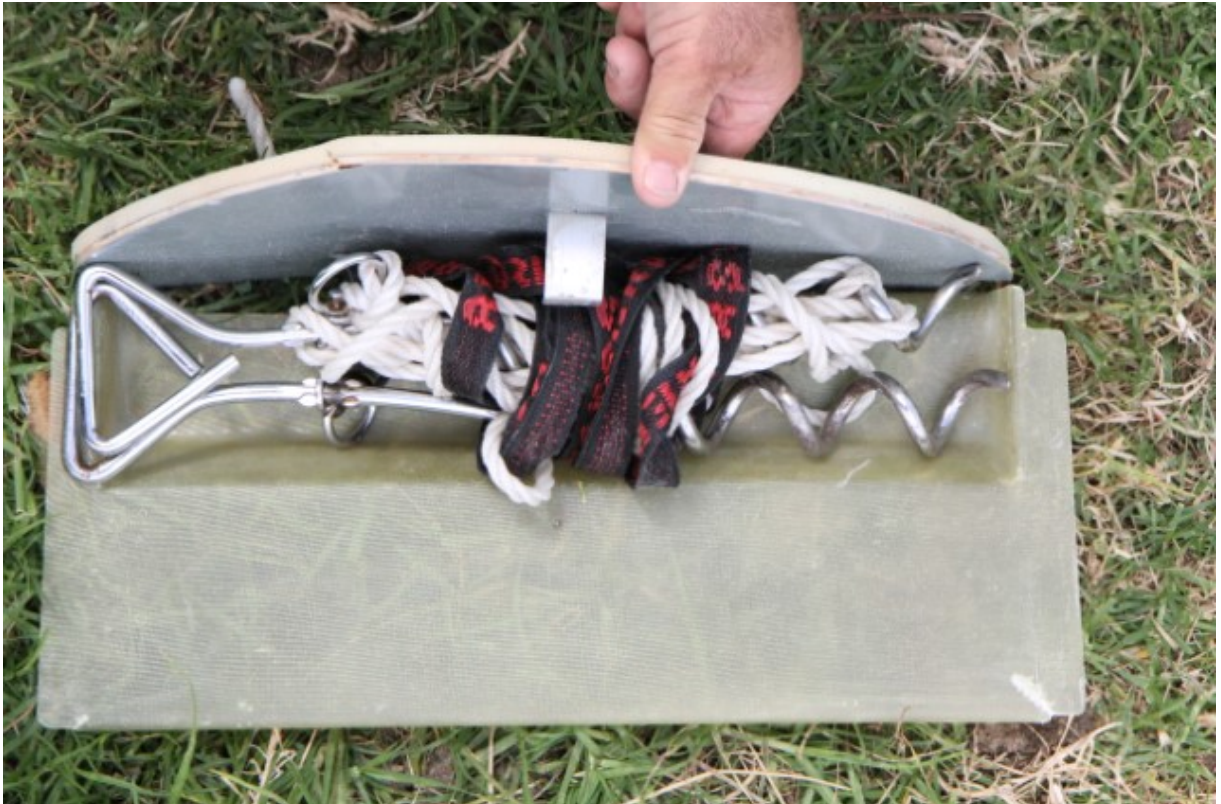
Demonstration of correct stowage tray to aft bulkhead installation.
