## What the Ops Team is Talking About . . .

Memo to Club CFI's and other interested parties - March 2020 - *please forward to your instructors.*  
A summary of the key items discussed at the Ops Team on-line meeting on 4 March 2020.  
David Moody (North), David Hirst (Central), Graham Erikson (South) and Martyn Cook (NOO).

### 1. Summary of Incident Reports for Jan - Feb 2020

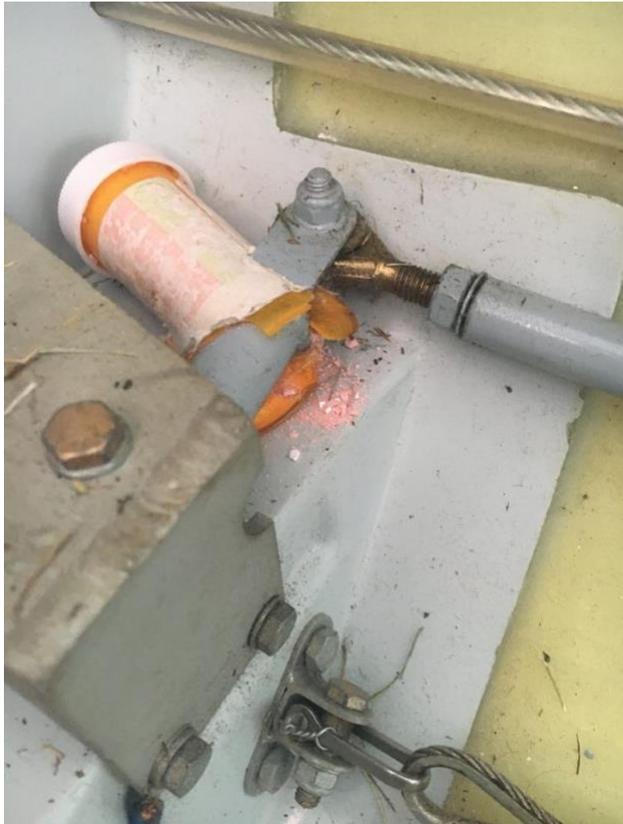
- near miss on short final (10m) - 4 gliders in circuit - overtaking underneath another glider
- near miss (60m) - 2 gliders joining circuit - radio/flarm no effect - unusual joining manoeuvre
- loose object (plastic pill bottle) prevented left aileron - force applied in flight to break bottle
- glider released at 400 ft after being severely displaced - attributed to sudden wind shear event
- glider flown multiple times with vibration in elevator - large gaps found with no sealing tape
- ASI intermittent on winch launches - normal operation on ground - insect parts inside fin pitot
- tractor operation on airfield conflicting with tow plane and glider ops - multiple events reported
- wheel up landing - undercarriage lever actuated on downwind but incorrect position selected

**Loose objects in fuselage:** this is not the first time a control malfunction has been caused by loose articles, in this case a pill container. Fortunately it was able to be crushed by applying force to the controls, and a degree of control could be restored (see photo). Other objects like pickets and rigging tools are less flexible and in the past have incapacitated the glider.

How to prevent these incidents? Firstly, zero tolerance on the DI for inadequately-secured items, including batteries, pickets, cameras, sunglasses, cell phones and other luggage.

Secondly, don't carry any item in the aircraft that is not going to be needed in flight.

Thirdly ensure that there are no gaps where loose articles can move into areas where controls run. Check that fabric shrouds around the control sticks are intact, parcel shelves are correctly-fitted, and there are no gaps underneath or behind seats where articles could slip through. In some aircraft the gaps around flap and trim levers are large enough to admit coins, keys, ballpoint pens and the like.
