Continuing Airworthiness Notice – 27-008

Schempp-Hirth Discus b and Discus CS gliders - Flight Controls

3 March 2015

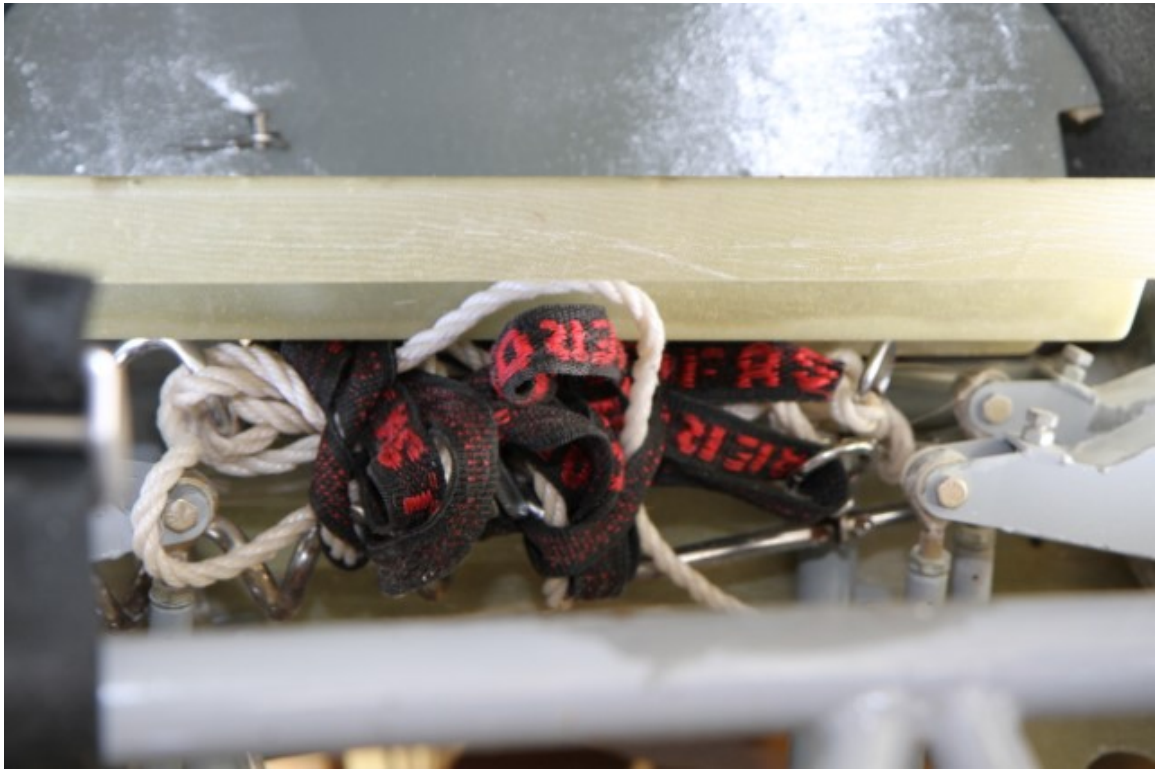
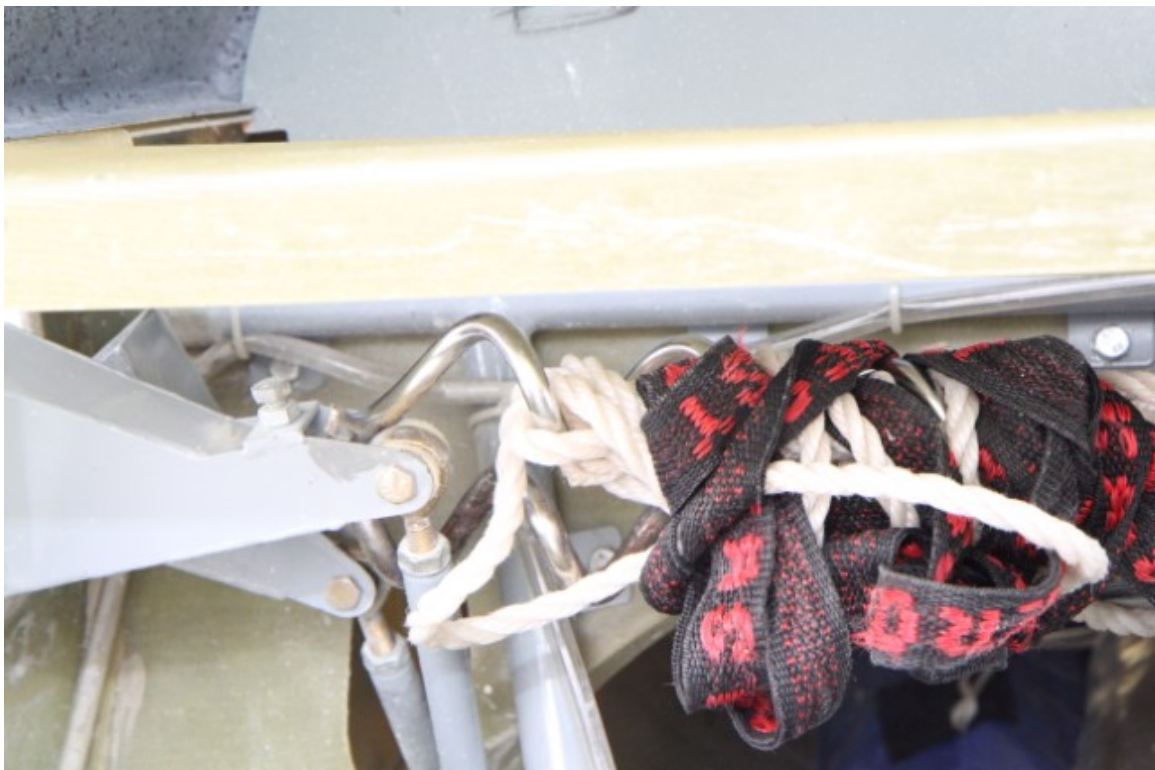
- Two picketing ropes and steel pegs were found jammed in the flight control mechanism located in the centre fuselage.
- The picketing equipment had fallen through the gap between the incorrectly installed stowage tray and the aft bulkhead.
- The picketing equipment restricted full aileron movement to starboard.
- The control system restrictions made the glider uncontrollable and the aircraft was destroyed.

Picketing equipment jammed in the centre fuselage flight control system.

The CAA strongly recommends that operators and maintainers of affected aircraft inspect the stowage tray for correct installation to ensure that there are no gaps through which stowed equipment can enter the fuselage and interfere with the flight control system.

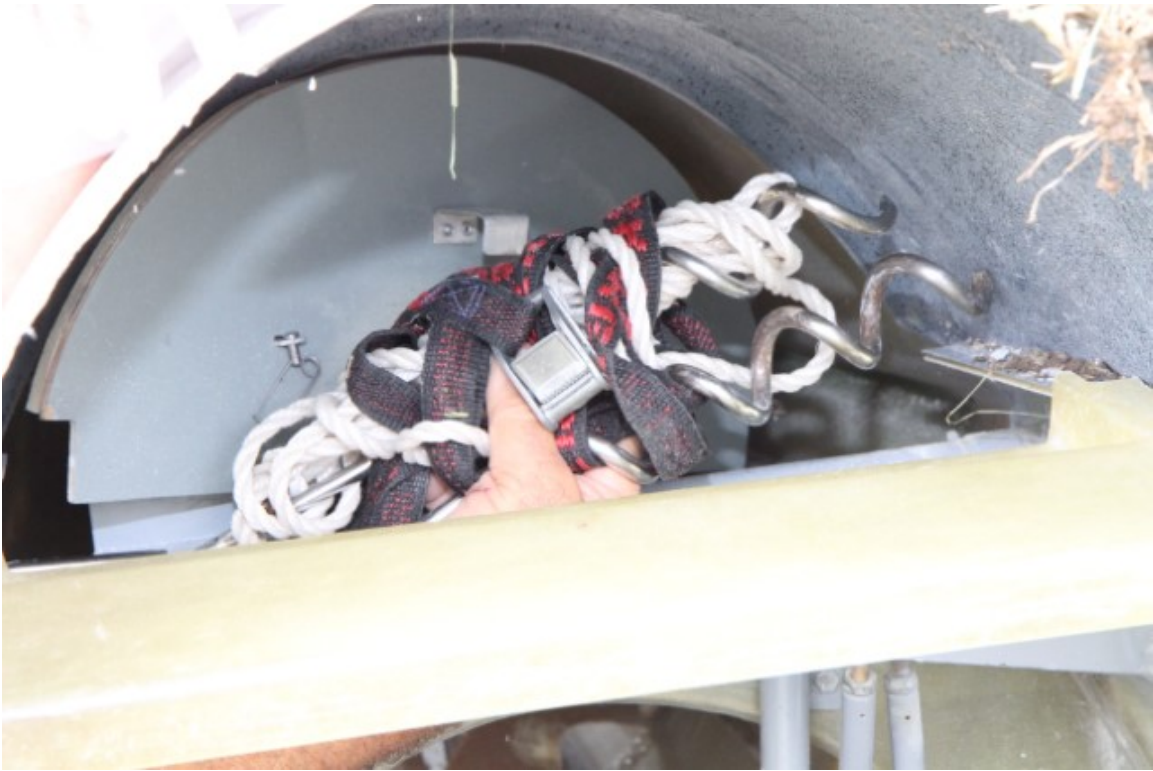
The CAA understands that there is a very specific installation sequence when installing the stowage tray and the aircraft wings. It appears that the stowage tray cannot be correctly located all the way to the aft bulkhead after the wings are installed. The incorrect installation creates an undetected gap between the aft bulkhead and the stowage tray through which stowed equipment can enter the flight control system.

Demonstration of the gap between the stowage tray and the aft bulkhead which is difficult to detect when looking aft.

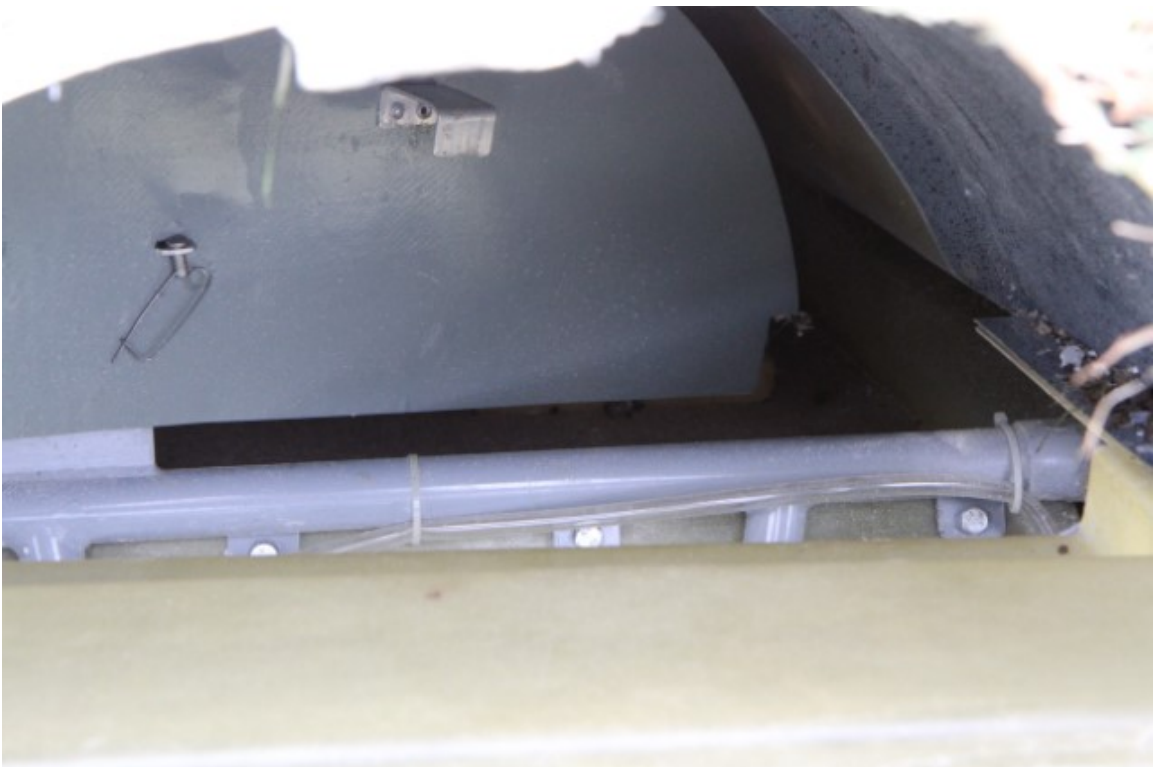
Stowage tray bulkhead to main fuselage detail.

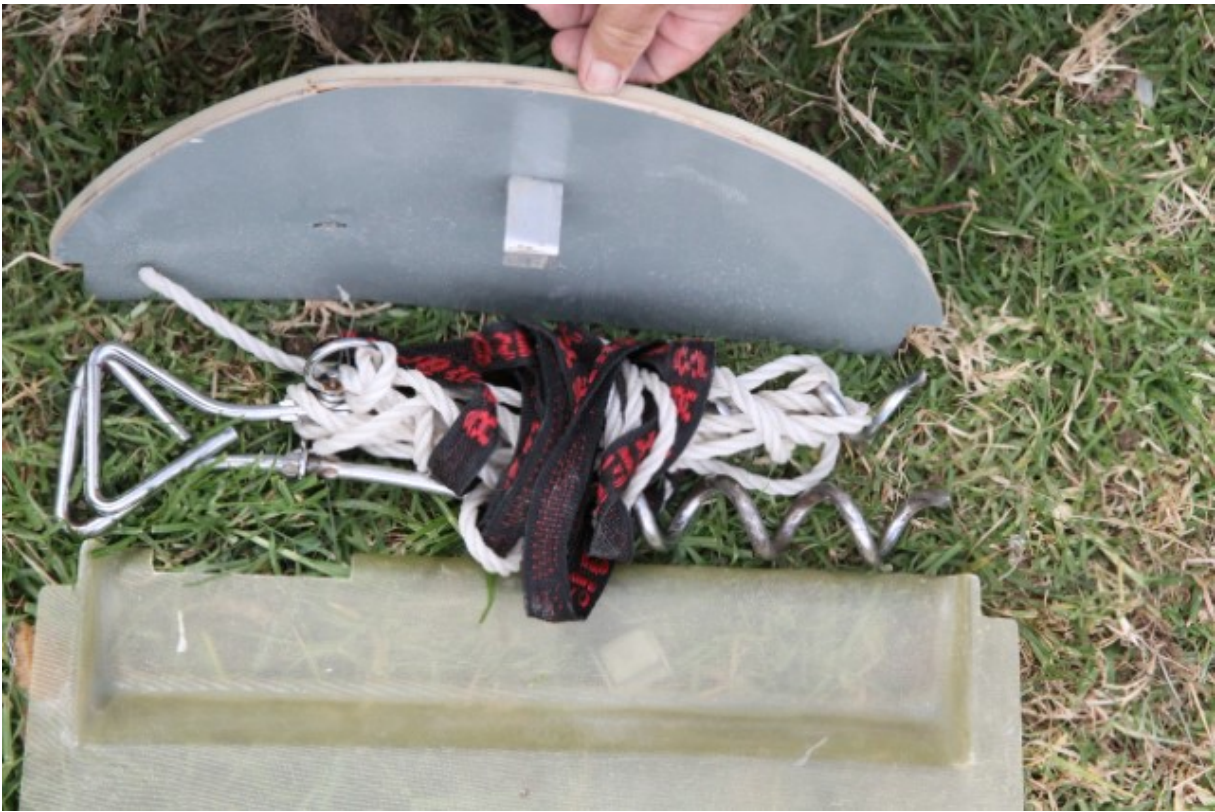
Demonstration of incorrect stowage tray to aft bulkhead installation and the resultant gap which results in an undetected gap through which stowed equipment can enter the flight control system.

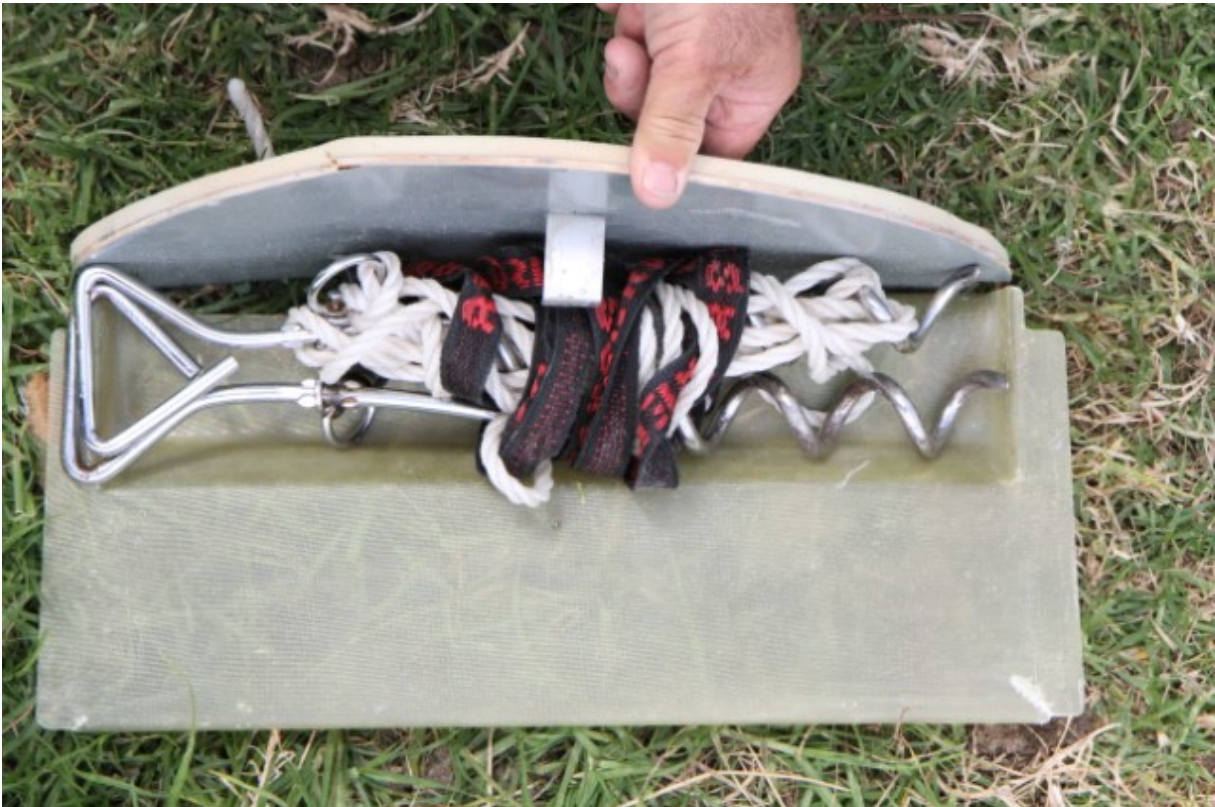
Demonstration of correct stowage tray to aft bulkhead installation.
