What the GNZ Operations Team is Talking About . . .

A summary of key items discussed at the Operations Team on-line meeting on 6 December 2023. Attended by David Moody (North), David Hirst (Central) and Martyn Cook (NOO).

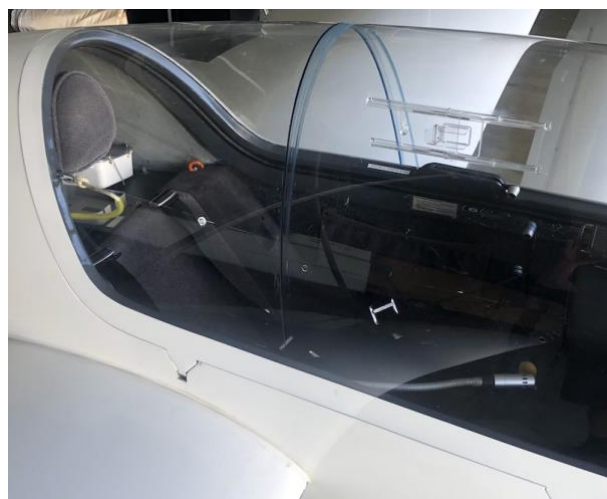
1.1 Winch cable draped over canopy: An instructor was being trained on how to teach and monitor a cable break during a winch launch. The trainee in the back seat reports, "At about 500 feet I pulled the cable release twice to simulate a rope break. The instructor trainer (IT) in the front seat pitched the nose down immediately, as a student would be trained to react. However, instead of holding the pitch at the recovery attitude (an attitude slightly lower than that required for the approach speed required), the IT continued to pitch the nose down slightly lower to simulate how an inexperienced student might react. I recognised this and, since I judged us to have sufficient height to recover and land ahead despite the lower nose attitude and increasing airspeed, I let the IT continue in this attitude until the speed reached around 80 knots. At this point, I took control and stated "I have control", before beginning to raise the nose to reduce the airspeed for a suitable approach. The speed peaked at around 100 knots. Almost immediately after I took control, I heard a loud bang on my (rear) canopy followed by a flapping/fluttering noise, and the left side of the canopy was obscured by a blue discolouration. A loud buzzing noise followed."

The IT in the front seat landed the glider straight ahead in the space available. After landing it became clear that "the winch cable had wrapped itself over the top of the rear canopy and been dragged into the gap between the left wing root and the fuselage. The canopy would not open more than a few millimetres until freed."

"There was severe marking to the rear canopy where the winch cable had rubbed across it, with a single deep gouge running left to right in line with the leading edge of the wings. This gouge looked to be most of the way through the plexiglass across the top of the canopy."

It appears that the glider had dived below the falling winch cable, then the nose of the glider snagged the cable as it slowed down. The dyneema cable ended up lying across the rear canopy and under each wing, and was dragged across the canopy by the tension from the opened parachute. This heated and deformed the plastic.
