## **What the GNZ Operations Team is Talking About . . .**

A summary of key items discussed at the Operations Team on-line meeting on 7 October 2025.

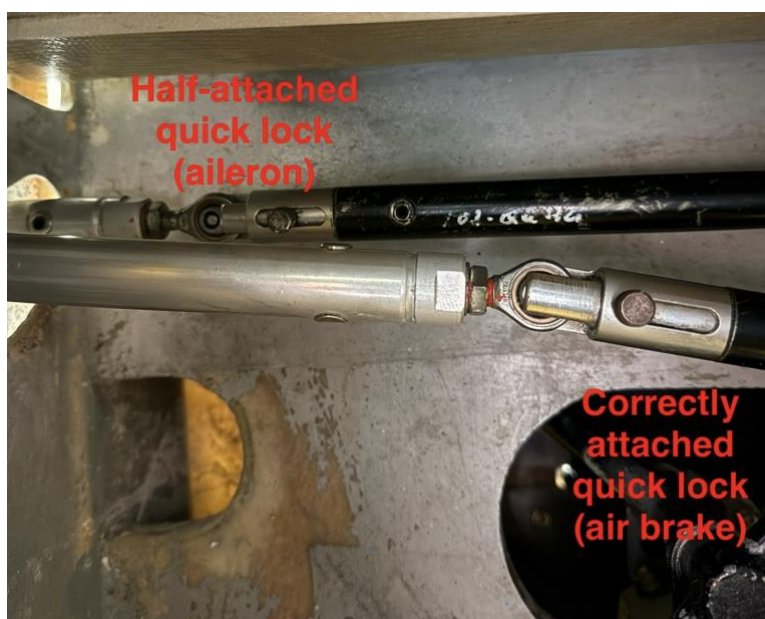
#### **1.1 Rigging Error Found After Duplicate Inspection**

The glider had been landed out and derigged for a trailer retrieve. It had been re-rigged and the duplicate control checks signed off, but not taped up or flown. A few days later the prospective pilot noted that, "As it was yet to be taped and I was first to fly this glider, I double checked the rigging. I found the left aileron's 'quick lock' was incorrectly attached in a half-closed position. It passed a positive control check, but the latch was not fully covering the pin and could have come undone in-flight." See annotated photograph below.
