AGC Newsletter 19/09/2025

Winter Make over for CEB by Wayne Thomas

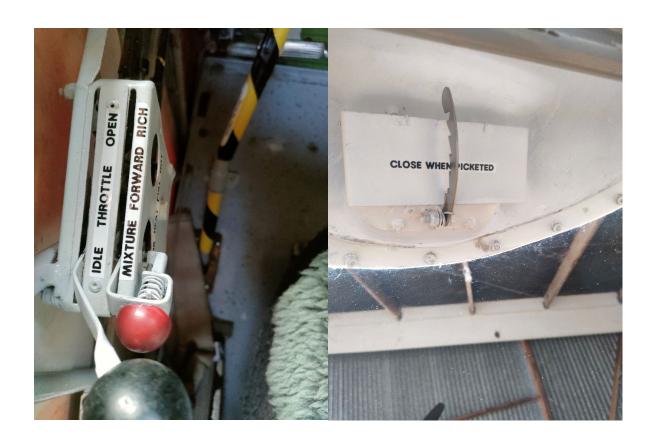
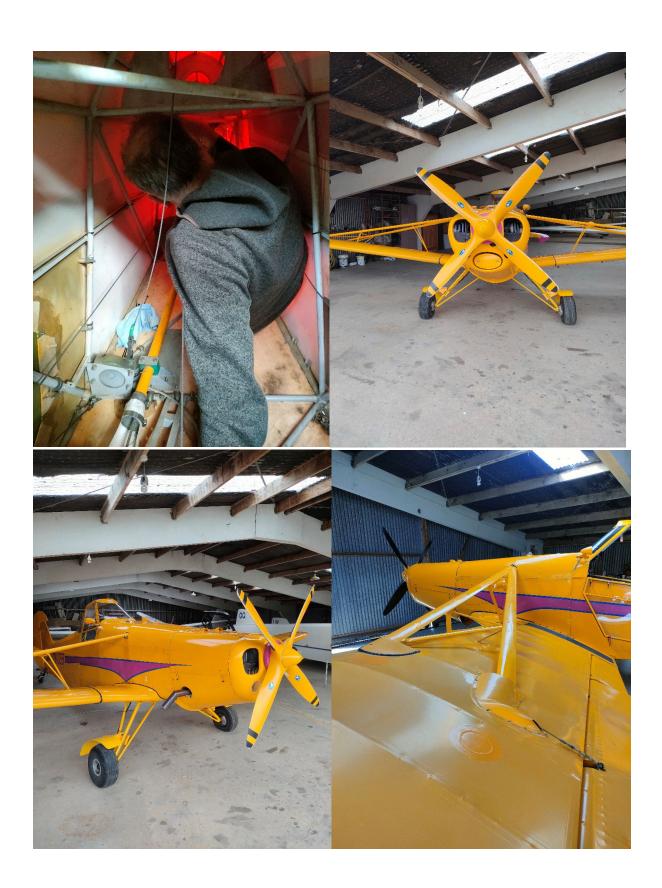
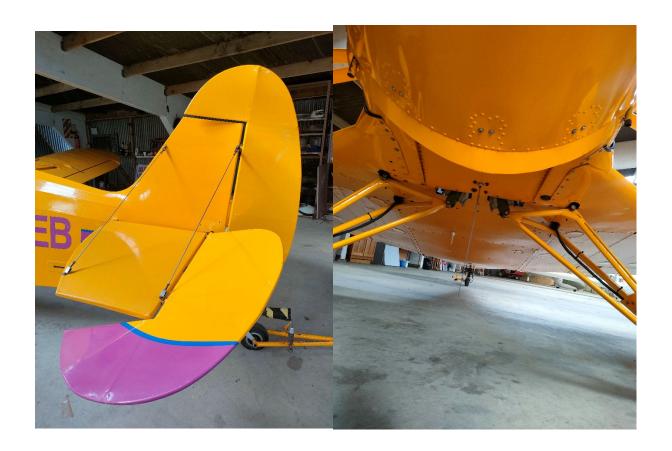
What started out as a small job certainly morphed into bigger than ben hur (well sort of). We were just going to take of the struts for their 4 yearly x-ray inspection and while they passed that test they didn't pass the test when the old leading edge tapes were taken off. Unfortunately, we found a few areas of spider corrosion along the leading edge. The paint was stripped, and the struts eventually sand blasted to remove the surface corrosion. After an etch primer followed by primer and 2 final coats, they were ready to be re attached. The supports were also sand blasted and painted.

While we were at it the inspection holes for the spar inspection were also painted a total of 12 panels. Other parts on the aircraft were also treated where corrosion was present, unfortunately will be on going. The rudder and left-hand elevator also came off and were repaired due to a broken support wire in each part. These were repaired by Rob McNair a specialist in the field of fabric repair. The air vent at the top of the windscreen was scrapped due to corrosion and Steve made a new replacement. The dash has been recovered, and you will see a new LED flarm unit installed.

The seat cover has been attached properly, and the throttle/Mixture quadrant has been repaired and re labelled. I managed to fly over to Ardmore the other day using the drier part of the airfield and had a new radio installed which we will be able to monitor 2 frequencies at once. Was supposed to be a 2-hour job but ended up being over there for 7 hours. Fortunately, I got to spend a bit of that time flying in Warbirds recently restored Tiger Moth, so I no complain. You will see a picture of Steve down in the fuselage (I did volunteer but seems logical you would get the tallest person to do the job) the pitot tube on the right side was full of water due to looping down so was reinstalled looping up so water wouldn't get trapped in the tube.

The propeller has been repainted on the rear and the front sanded back to flair the edge which needs a bit of repaint. Thanks to Pat who washed the plane the other day and I managed to clean the underside of the aircraft which should all add a few more knots to our cruise. A bit of cut and polishing has been done also so hopefully we will get a few more volunteers to keep going or a bit of titivating while waiting for the next tow.
